Impact of Solar Cell Cracks Caused During Potential Induced Degradation (PID) Tests

Mahmoud Dhimish, *Member, IEEE*, Jeff Kettle, *Member, IEEE*

Abstract— Potential-induced degradation (PID) of photovoltaic (PV) modules is one of the most severe types of degradation in modern modules, where power losses depend on the strength of the electric field, the temperature and relative humidity and the PV module materials. Understanding how module defects impact PID is key to reducing the issue. This work investigates the impact of cracks and fractural defects in solar cells and their impact on PID. We have tested using electroluminescence (EL) imaging how solar cells with varying levels of cracks/defects impact PID and our results indicate that such defects have a sizeable influence on the PID. We also confirmed the strong relationship between the size of the initial defect/crack and the presence of hotspots. As the crack (dark) area increased, there was a further increase in the cell's temperature under standard test conditions. In this work, it is observed that minor cracks in solar cells have no considerable PID effect for the solar cells providing some reassurance that quality contro

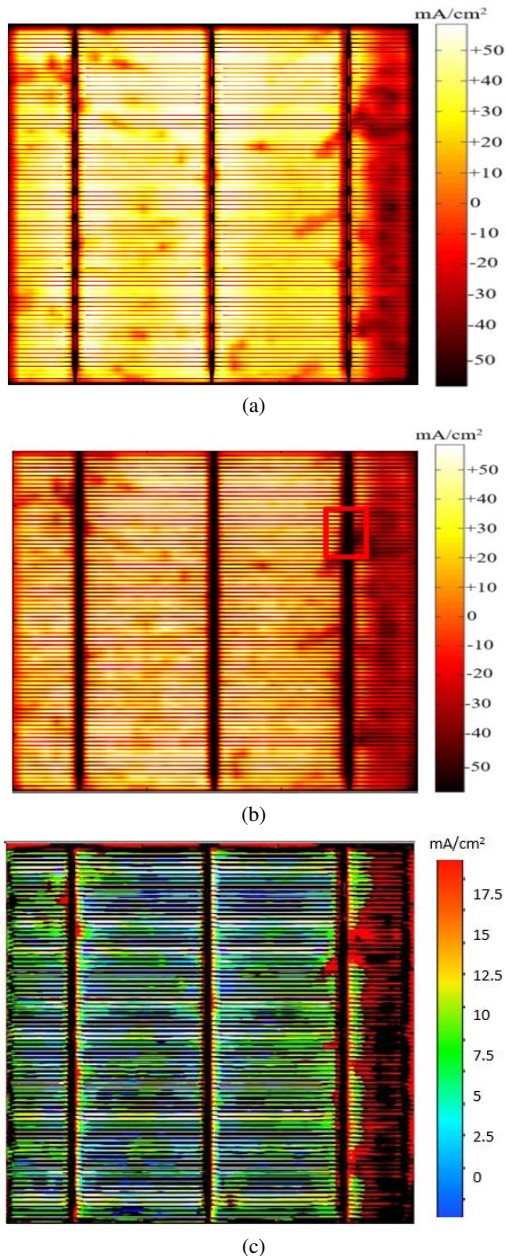
Now consider the behavior of solar cell sample #2, where the LBIC images before the PID test began is shown in Fig. 7(a). The dark area on the right-hand side of the solar cell clearly exhibits a drop in the J_{sc} . In agreement with the earlier data, the J_{sc} reduced significantly after the PID test was completed (Fig. 7(b)). Remarkably, the images indicate that the dark area is likely to be causing a more severe PID to the cell. There is a noticeable expansion of the dark regions across the right-hand side where the original EL image has an initial dark area.

The difference between the J_{sc} before and after the PID test is shown in Fig. 7(c). There is a significant drop in the current on the right-hand side of the solar cell, which is the same area that had the initial shading/defect. This confirms that such dark areas in the original EL images can be classified as high-risk regions for PID degradation in solar cells.

Fig. 7. J_{sc} for Solar cell #2. (a) before the PID test, (b) after the PID is completed, (c) Difference in the J_{sc} before and after the PID test.

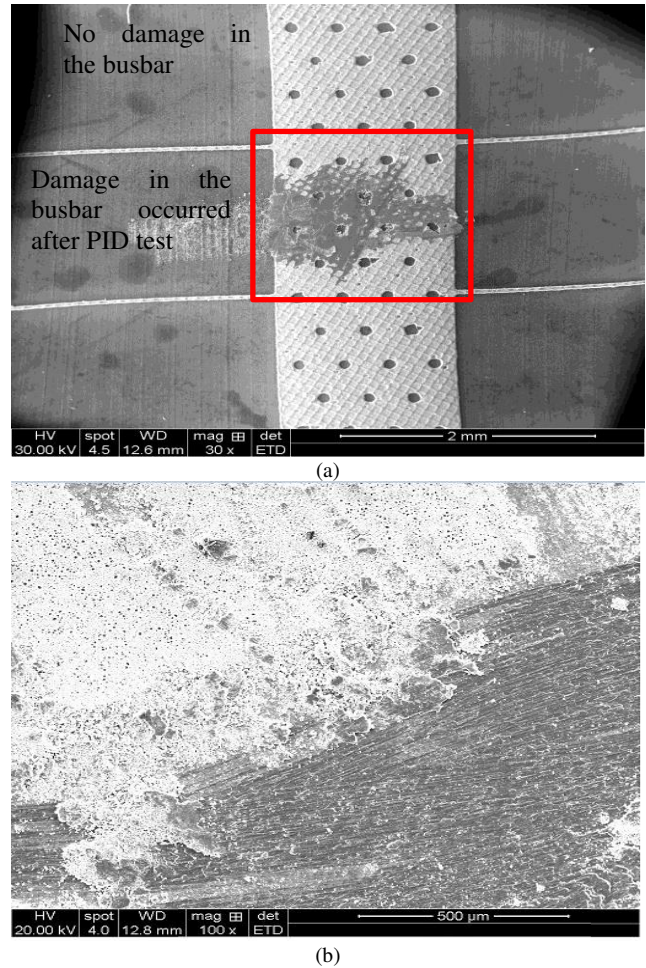
We have taken the SEM image of the labelled area in Fig 7(b) for further examination. The output image of the inspection is shown in Fig. 8(a). We have witnessed that after performing the PID test, the dark area (potential crack) damaged the busbar, this is evident by the front surface view.

In Fig. 8(b), we have observed at the back surface of the busbar. The PID test initiated further damage to the rear surface of the solar cell sample. There are a number of 'pits' in the contacts and material migration from the contact areas. As a result, we prove that it is likely to have a critical PID for a solar cell that comprises entirely/partially dark regions in the original EL image.

Fig. 8. SEM for solar cell #2. (a) front surface, (b) Back surface.

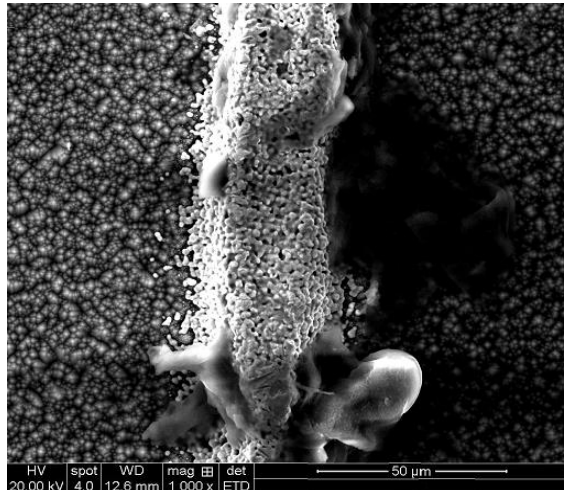
In contrast, we have further investigated the labelled area in Fig. 9(b), using an SEM. The result of the SEM inspection is displayed in Fig. 10. By inspection of the busbar's metallic (solder) joint to the solar cell surface, it is evident that the solder has migrated and deformed around the solder joint. This microscopic observation leads to understand why some solar cells, after PID tests, demonstrate significant decreases in the output current; clearly these changes lead to the development of hotspots and open circuits forming at the solder joints.

Fig. 10. SEM image for the front surface of the labelled area in Fig. 9(b).

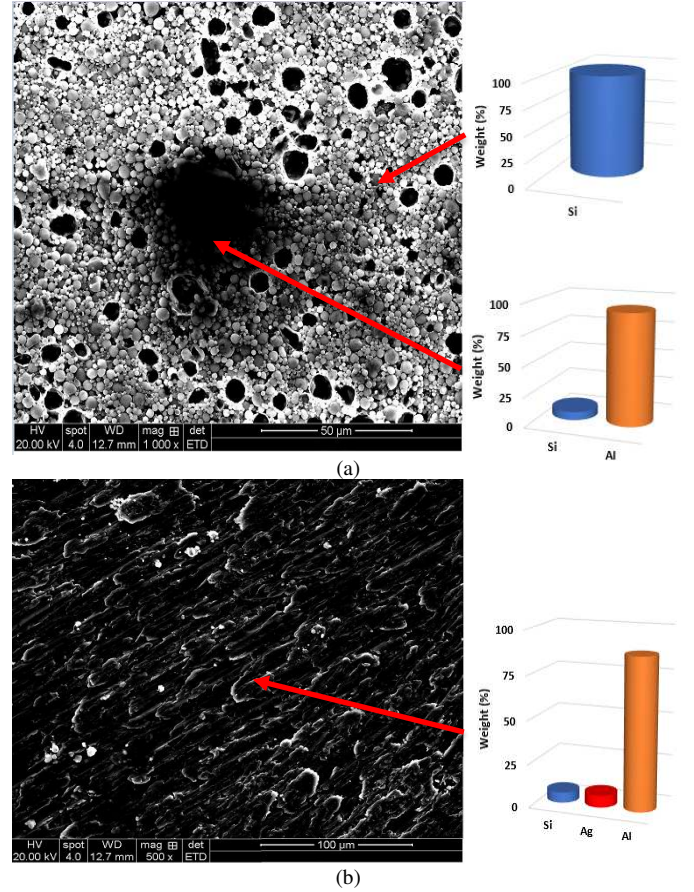
The breakdown areas were analyzed using a SEM. For example, the output SEM image for A1 is shown in Fig. 13(a). It appears that the crack has initiated a significant breakdown in the cell (the black area in the middle of Fig. 13(a)) and hundreds of similar potential breakdown blocks in the surrounding area. The white areas in the image represent are measured as Silicon using Energy-dispersive X-ray spectroscopy (EDX). In comparison, the black area corresponds to aluminum (Al), indicating that a large defect in the solar cell, and the solar cell rear contact (made of Al) is only visible. Additionally, the SEM image for A2 is shown in Fig. 13(b); only 6% silicon was found in this area, along with 7% silver (Ag) due to the expansion of the busbar material and 87% of Al. Accordingly, this part of the solar cell has a complete breakdown, not generating any photocurrent.

In reviewing the abovementioned observations, the breakdown area in the solar cell sample #4 leads to a drop in the J_{sc} after the PID test was completed and a further breakdown area adjacent to the initial breakdown. These observations suggest the following:

Fig. 13. (a) SEM image for the front surface of area A1, (b) SEM image for the front surface of area A2.
